Dunedin City Holdings Limited

Review of Aurora Energy Limited / Delta Utility Services Limited – Network Safety Concerns

December 2016

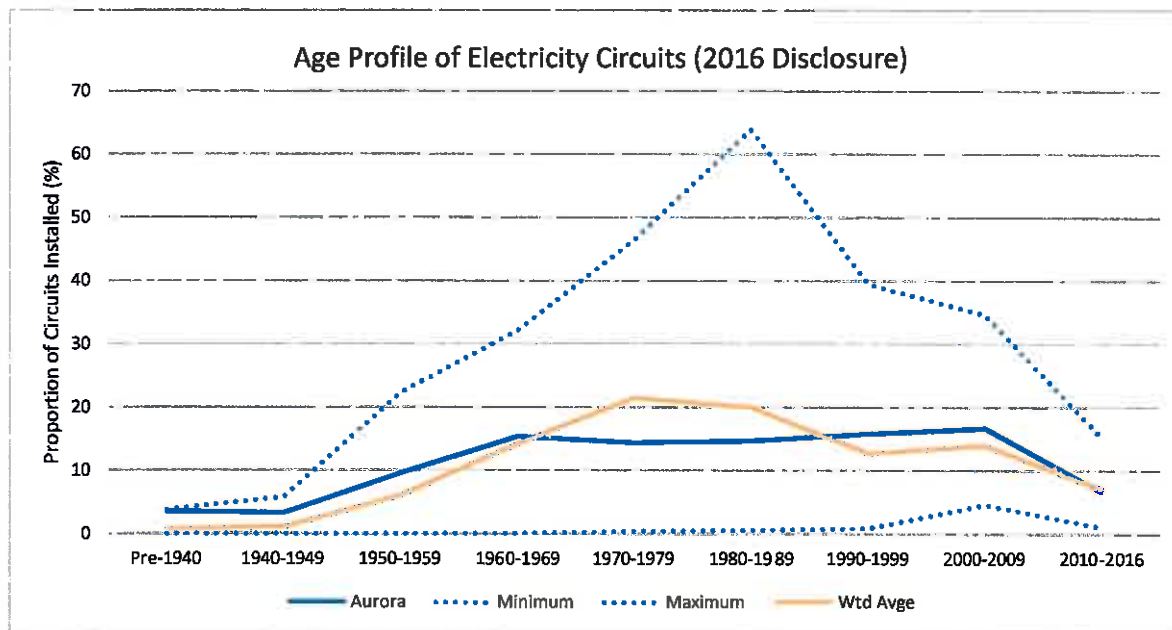
The Aurora network is an aged network. The chart below shows the age profile of electricity circuits installed by decade for Aurora in comparison to the range of profiles and weighted average for the industry.

Higher than average proportions of the Aurora network were constructed at either end of the profile, providing a mixed picture, although the long tail by age is predominantly associated with Dunedin.

- The graph above highlights that the Aurora network is not an outlier with respect to its age profile. The estimated useful lives of the respective components that make up the network are well known from both an industry and company perspective. This should therefore lend itself well to planning for future maintenance and replacement strategies.
